# Manhole Inspection Summary

Manhole # S41WW\_003MH

Insp Date: **4/3/07 9:23 AM**

**Location** Address: **3220 LOCH RAVEN BLVD** Cross Street: **GORSUCH AVE**

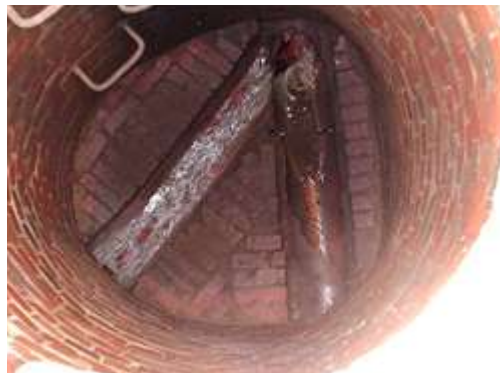
Top View

Corbel and Barrel infiltration. Bench debris.

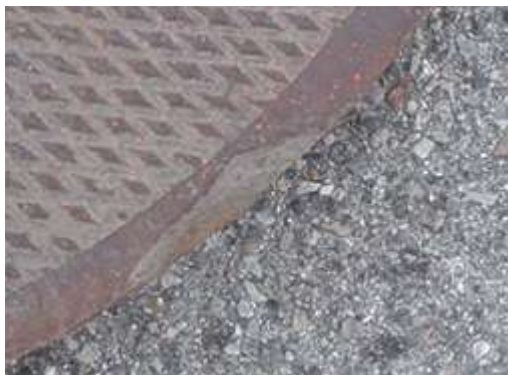
Worn lid

**Cover** Shape: **Circular** Diameter: **30** (in.) Length: (in.) Dist A/B Grade: **0** (in.)  
Type: **Sanitary** Condition: **Worn** Cover Material: **Cast Iron**  
Properties: ☐ Bolted ☐ Vented ☐ Water Tight ☐ Water Tight Insert

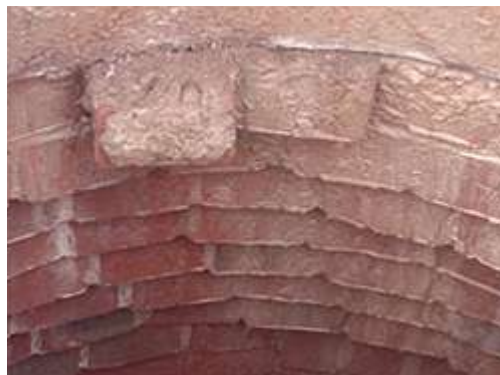
Defect

**Frame** Offset: **1** (in.) Condition: ☐ Sound ☐ Cracked ☒ **Leaks**

**Chimney / Frame Adjustment** ☒ Exists Material: **Brick** ☐ Parged Height: **6** (in.)  
Condition: ☐ Sound ☐ Cracked ☐ Root Intrusion ☒ **Loose Brick** ☒ **Deteriorated**  
Infiltration: ☐ None ☒ **Joint** ☐ Cracks ☐ Mortar ☐ Roots ☒ **Wall**

Frame leaks. Adjustment deterioration, loose brick and infiltration.

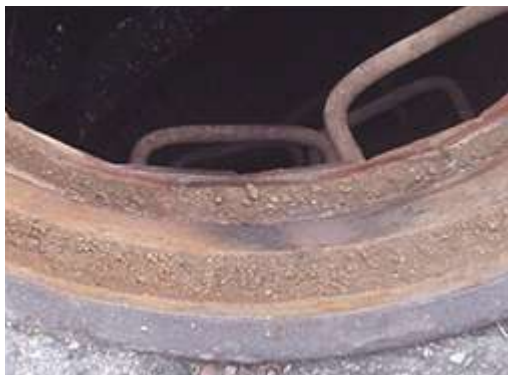
Defect

Frame leaks. Frame offset.

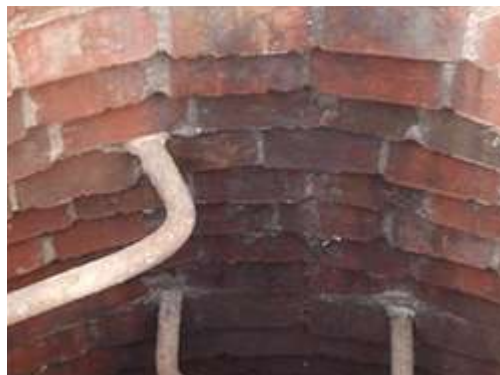
Defect

**Corbel** Material: **Brick** ☐ Parged Type: **Concentric/Eccentric**  
Condition: ☒ Sound ☐ Cracked ☐ Root Intrusion ☐ Loose Brick ☐ Deteriorated  
Infiltration: ☐ None ☐ Joint ☐ Cracks ☐ Mortar ☐ Roots ☒ **Wall**

Corbel infiltration.
